**Flood Control Project Maintenance  
Levee Inspections**

## Maintenance Issue Types Only, Levee Inspection Report By Mile - Spring 2019

### Reclamation District No. 0003 Grand Island

Waterway	Bank	Unit Miles	Inspection Start/End	Inspector
Unit No. 01 Left Bank Steamboat Slough	Left	10.95	04/03/2019 04/03/2019	David Julian

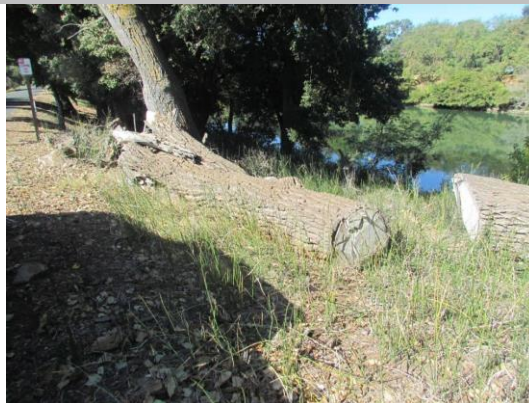
Photo 2 of 2 : SP\_2019\_RD0003\_24\_19\_20190311\_00018.jpg

Looking west at tree branch on waterward shoulder and slope. (Fall 2016)

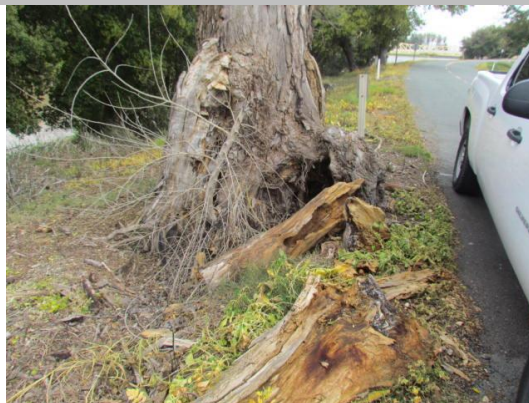
Photo 1 of 3 : SP\_2019\_RD0003\_24\_2\_20190311\_00001.jpg

LM Start	0.13	Rating **	M	Issue No.	2	
LM End	0.13	Issue Type +	Ma	Location *	WS	
Category	Earthen Levee			GPS Latitude/Longitude		
				Start		End
Item	Erosion / Bank Caving			38.303303°	38.303303°	
				-121.576538°	-121.576538°	
DWR ID	DWR_RD0003_01_f_2013_2					
Comment Code						
E2 : Schedule repair of erosion site prior to the next inspection.						
Inspector Comment						
A hole (8ft x 2.5ft x 5ft) is next to a large tree on waterward shoulder.

Looking east at hole at the base of an oak tree on the waterward shoulder. (2016)

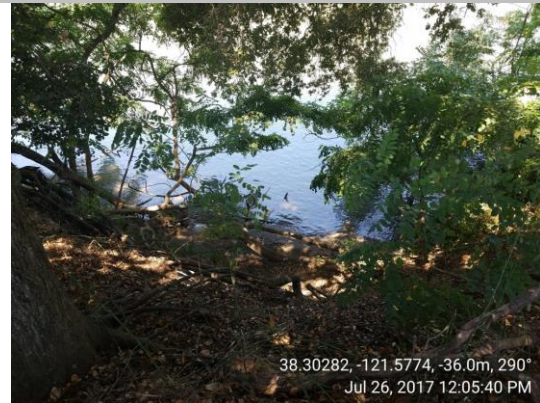
Photo 2 of 3 : LEVAL\_SP\_2019\_274\_2392.jpg

LM Start	0.18	Rating **	A/W	Issue No.	52 (cont)
LM End	0.21	Issue Type +	Ma	Location *	WS
Category	Supplemental			GPS Latitude/Longitude	
				Start	End
Item	2017 Storm Damage			38.302981 °	38.302778 °
				-121.577336 °	-121.577683 °
DWR ID	DWR_RD0003_01_s_2018_52				
Comment Code					
Inspector Comment					
Levee Evaluation Comments					
Description: District station 9+63 to 10+85, Sec. 07, T. 5 N. R. 4 E., M.D.M. An erosion site exists along approximately 122 linear feet of the waterside slope of Steamboat Slough (Unit 1). Erosion commences approximately 1/3 of the way down the slope from the crown to the waterside toe. Erosion is undercutting existing trees.					
Site ID No: 274					
Site Designation: LMA-100					
Repair Type: Erosion					
Rating: Serious					
Field Date: 7/26/2017					
Notes: trees undercut by erosion

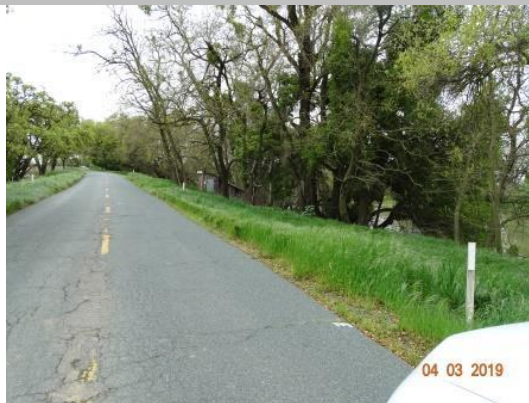
Photo 1 of 1 : SP\_2019\_RD0003\_24\_88\_20190403\_00168.jpg

View looking downstream at annual vegetation on the waterside slope (Spring 2019).

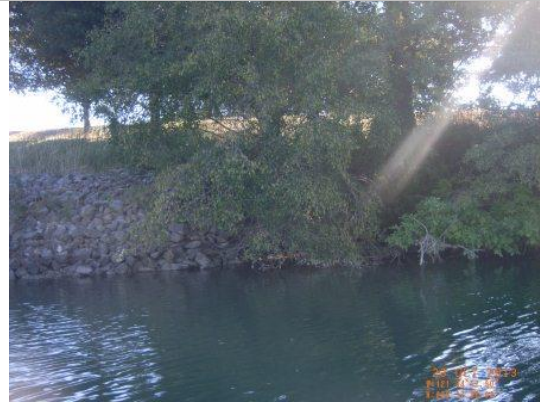
Photo 1 of 1 : SP\_2019\_RD0003\_24\_49\_20190311\_00030.jpg

Comment Code					
Inspector Comment					
2017 Site ID: STM 25.0 L					
Status: Critical					
2018: Deep erosion into levee toe. Roots are exposed. I would consider this critical.					
2017 Field Notes: Upgraded to critical. Site has eroded to near vertical at upstream end.					
Site History: 1997 - Erosion of sandy levee on top left bank. Site is downstream of a rock section. Large riparian trees on the bank. 1999 - Upstream half of the reach repaired with rock, except for a 30 ft reach at the upstream end. 2001 - Rock repair on the upstream and downstream ends; no revetment at the trees. 2002 - Rock repair is starting to slide off the geotextile at the upstream end. 2005 - One new small tree has fallen. 2006 - 50 ft pocket at the downstream end and at the upstream end with new rock in between. 2007 - Upstream end has been repaired. 2008 - Area closed sign on bank. Newly fallen trees at both ends and pop outs along the bank. 2010 - Site extended downstream. 2011 - New erosion at the toe. More trees popouts. 2013 - Short vertical sections observed at the downstream end. 2015 - Significant new erosion, large oak tree on verge of popping out. 2016 - Sites 24.8 and 25 were combined.

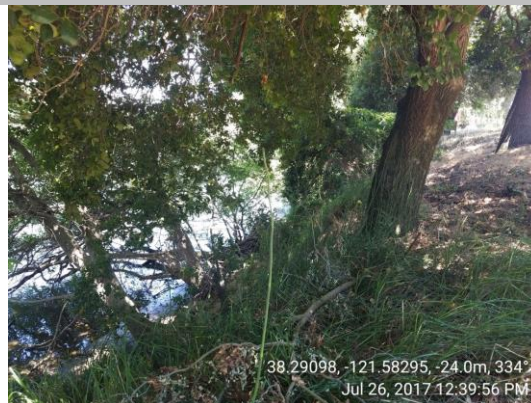
Photo 2 of 3 : SP\_2019\_RD0003\_24\_60\_20190311\_00047.jpg

LM Start	1.09	Rating **	A/W	Issue No.	60 (cont)	
LM End	1.10	Issue Type +	Ma	Location *		
Category	Supplemental			GPS Latitude/Longitude		
				Start	End	
Item	2017 Storm Damage			38.290819 °	38.290706 °	
				-121.582942 °	-121.582939 °	
DWR ID	DWR_RD0003_01_f _ 2017_60					
Comment Code						
Inspector Comment						
Levee Evaluation Comments						
Description:District station 57+57 to 57+98, Sec. 18, 1. 5 N. R. 4 E., M.D.M. An erosion site exists along approximately 41 linear feet of the water side slope of Steamboat Slough (Unit 1). The erosion commences approximately 1/2 of the way down the slope from the crown to the waterside toe.						
Site ID No:276						
Site Designation:LMA-102						
Repair Type: Erosion						
Rating:Area of Concern						
Field Date:7/26/2017						
Notes:

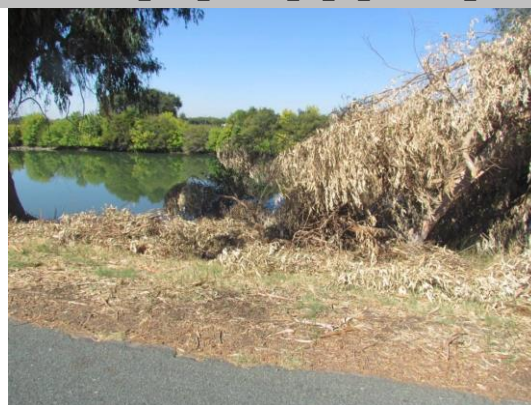
Photo 1 of 2 : SP\_2019\_RD0003\_24\_62\_20190311\_00049.jpg

LM Start	1.69	Rating **	M	Issue No.	62
LM End	1.69	Issue Type +	Ma	Location *	WS
Category	Earthen Levee			GPS Latitude/Longitude	
				Start	End
Item	Encroachments			38.283747 °	38.283747 °
				-121.587622 °	-121.587622 °
DWR ID	DWR_RD0003_01_f_2016_62				
Comment Code					
TR : Tree or limb					
Inspector Comment					
There is a broken tree branch on the waterward slope.

Looking southwest at broken branches on waterward slope.

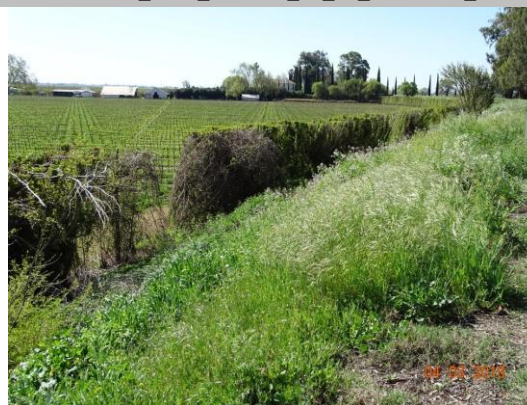
Photo 1 of 1 : SP\_2019\_RD0003\_24\_65\_20190311\_00054.jpg

Landside vegetation.

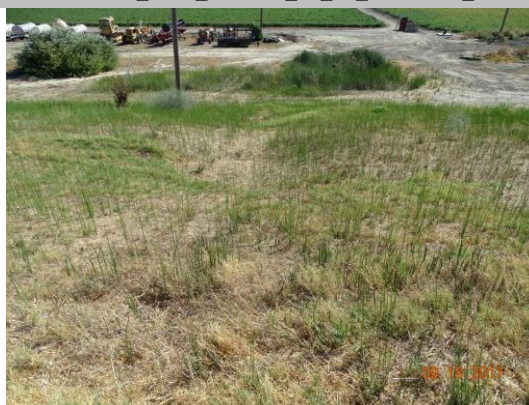
Photo 1 of 1 : SP\_2019\_RD0003\_24\_83\_20190311\_00076.jpg

LM Start	4.87	Rating **	M	Issue No.	83
LM End	4.87	Issue Type +	Ma	Location *	LS
Category	Earthen Levee			GPS Latitude/Longitude	
				Start	End
Item	Slope Stability			38.245903 °	38.245903 °
				-121.600851 °	-121.600851 °
DWR ID	DWR_RD0003_01_f_2017_83				
Comment Code					
S1 : Repair slope instability.					
Inspector Comment					
The landside slope has a depression.

Looking east on landside slope.

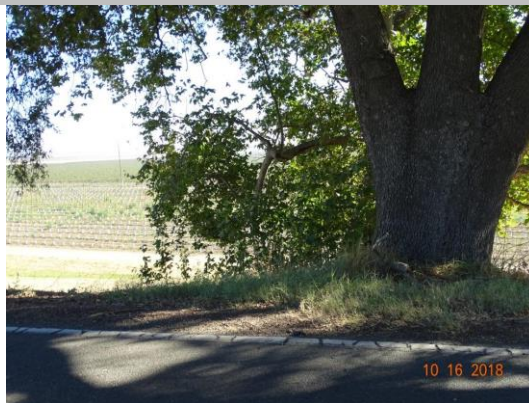
Photo 1 of 2 : SP\_2019\_RD0003\_24\_63\_20190311\_00051.jpg

View of slope where tree limb was removed. Now the extra growth on the existing branches needs to be removed (October 2018).

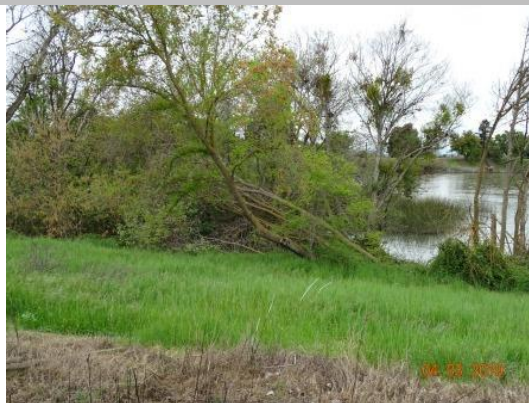
Photo 1 of 1 : SP\_2019\_RD0003\_24\_89\_20190403\_00173.jpg

View looking downstream at fallen tree on the waterside slope (Spring 2019).

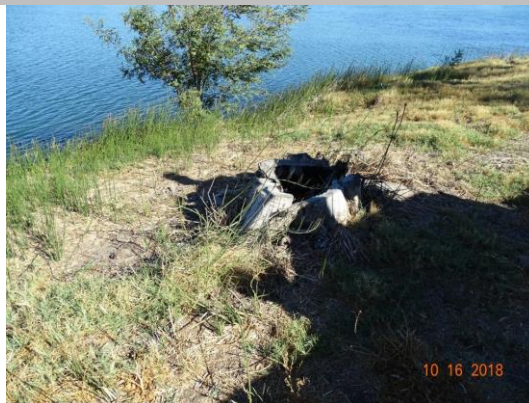
Photo 1 of 1 : SP\_2019\_RD0003\_24\_39\_20190311\_00026.jpg

View of rotting tree stump on water side crown (October 2018).

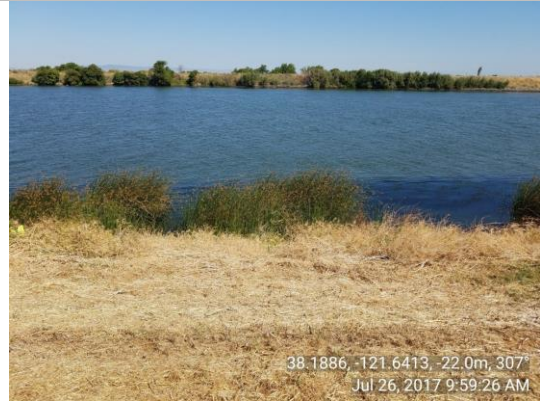
Photo 3 of 3 : SP\_2019\_RD0003\_24\_72\_20190311\_00062.jpg

LM Start	10.15	Rating **	A/W	Issue No.	72 (cont)	
LM End	10.21	Issue Type +	Ma	Location *		
Category	Supplemental			GPS Latitude/Longitude		
				Start	End	
Item	2017 Storm Damage			38.188431 °	38.187803 °	
				-121.641703 °	-121.642478 °	
DWR ID	DWR_RD0003_01_f_2017_72					
Comment Code						
Inspector Comment						
Levee Evaluation Comments						
Description:District station 536+35 to 539+47, Sec. 16, T. 4 N. R. 3 E., M.D.M. The waterside slope experienced sloughing and erosion along approximately 312 linear feet of Steamboat Slough (Unit 1). Sloughing commences at approximately 1/4 of the way down the slope from the crown and extends to the rip rap.						
Site ID No:277						
Site Designation:LMA-103						
Repair Type: Erosion						
Rating:Area of Concern						
Field Date:7/26/2017						
Notes:

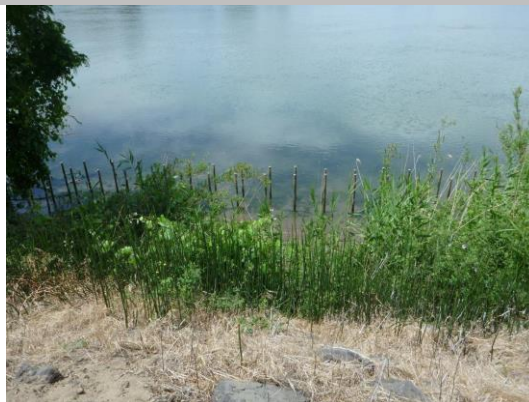
Photo 2 of 3 : SP\_2019\_RD0003\_24\_73\_20190311\_00064.jpg

LM Start	10.67	Rating **	A/W	Issue No.	73	
LM End	10.92	Issue Type +	Ma	Location *		
Category	Supplemental			GPS Latitude/Longitude		
				Start	End	
Item	2017 Storm Damage			38.183810 °	38.182480 °	
				-121.648780 °	-121.653150 °	
DWR ID	DWR_RD0003_01_f_2017_73					
Comment Code						
Inspector Comment						
Levee Evaluation Comments						
Description:						
Site ID No:63						
Site Designation:DWR_RD0003_01_R_2012_03						
Repair Type: Erosion						
Rating:Serious						
Field Date:6/8/2017						
Notes: scattered erosion scarps caving into levee crown, within erosion limit crown width ranges from 15 to 30', several trees with exposed tree roots and leaning into the river.

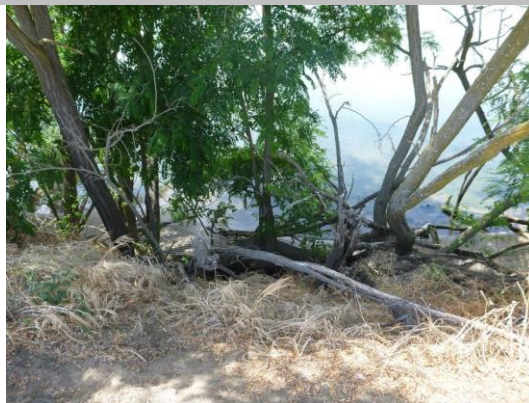
Photo 3 of 3 : SP\_2019\_RD0003\_24\_73\_20190311\_00065.jpg

LM Start	10.67	Rating **	A/W	Issue No.	73 (cont)
LM End	10.92	Issue Type +	Ma	Location *	
Category	Supplemental			GPS Latitude/Longitude	
				Start	End
Item	2017 Storm Damage			38.183810 °	38.182480 °
				-121.648780 °	-121.653150 °
DWR ID	DWR_RD0003_01_f_2017_73				
Comment Code					
Inspector Comment					
Levee Evaluation Comments					
Description:					
Site ID No:63					
Site Designation:DWR_RD0003_01_R_2012_03					
Repair Type: Erosion					
Rating:Serious					
Field Date:6/8/2017					
Notes: scattered erosion scarps caving into levee crown, within erosion limit crown width ranges from 15 to 30', several trees with exposed tree roots and leaning into the river.

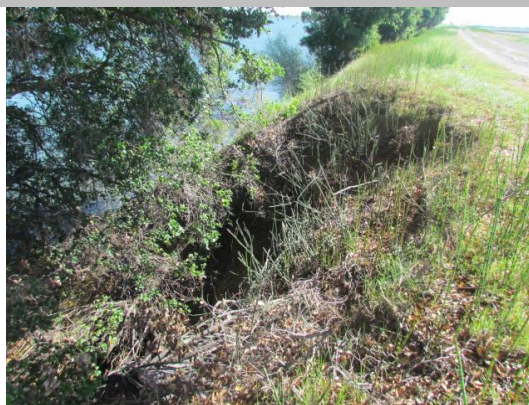
Photo 1 of 2 : SP\_2019\_RD0003\_24\_96\_20190311\_00082.jpg

LM Start	10.75	Rating **	A/W	Issue No.	96
LM End	10.75	Issue Type +	Ma	Location *	WS
Category	Earthen Levee			GPS Latitude/Longitude	
				Start	End
Item	Erosion / Bank Caving			38.183422 °	38.183422 °
				-121.650182 °	-121.650182 °
DWR ID	DWR_RD0003_01_s_2013_96				
Comment Code					
E2 : Schedule repair of erosion site prior to the next inspection.					
Inspector Comment					
Levee is extra wide in this section. Erosion is occurring outside the theoretical prism.

Looking northwest at erosion on waterward slope.

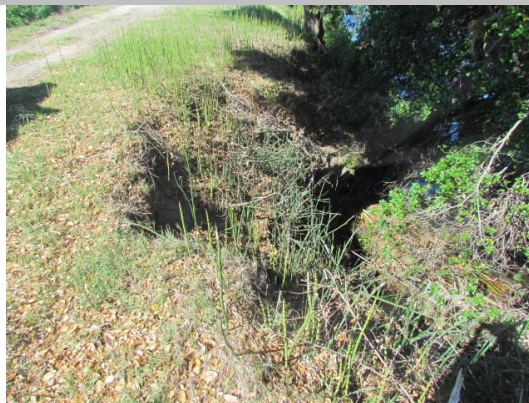
Photo 2 of 2 : SP\_2019\_RD0003\_24\_96\_20190311\_00083.jpg

LM Start	10.75	Rating **	A/W	Issue No.	96 (cont)	
LM End	10.75	Issue Type +	Ma	Location *	WS	
Category	Earthen Levee			GPS Latitude/Longitude		
				Start		End
Item	Erosion / Bank Caving			38.183422 °		38.183422 °
				-121.650182 °		-121.650182 °
DWR ID	DWR_RD0003_01_s_2013_96					
Comment Code						
E2 : Schedule repair of erosion site prior to the next inspection.						
Inspector Comment						
Levee is extra wide in this section. Erosion is occurring outside the theoretical prism.

Looking southwest at erosion on waterward slope.

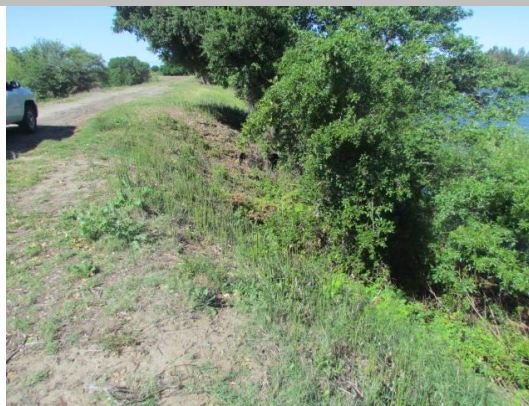
Photo 1 of 2 : SP\_2019\_RD0003\_24\_97\_20190311\_00084.jpg

LM Start	10.78	Rating **	A/W	Issue No.	97
LM End	10.80	Issue Type +	Ma	Location *	WS
Category	Earthen Levee			GPS Latitude/Longitude	
				Start	End
Item	Erosion / Bank Caving			38.183228 °	38.183123 °
				-121.650797 °	-121.651070 °
DWR ID	DWR_RD0003_01_s_2013_97				
Comment Code					
E2 : Schedule repair of erosion site prior to the next inspection.					
Inspector Comment					
Levee is extra wide in this section. Erosion is occurring outside the theoretical prism.

Looking south at erosion on waterward slope.

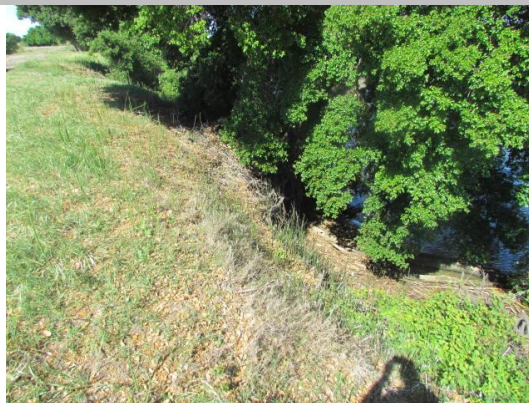
Photo 2 of 2 : SP\_2019\_RD0003\_24\_97\_20190311\_00085.jpg

Looking southwest at erosion on waterward slope.

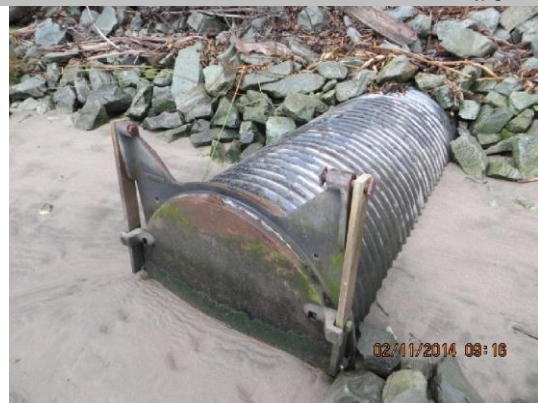
Photo 1 of 3 : UCIP\_SP\_2019\_29165\_53866.jpg

Comment Code					
Inspector Comment					
FS_ID:29165 DS_ID:22206 EP_NO: N/A Repair Type: Non-Urgent Crossing Status: Found UCIP Comments: Pipe appears abandoned and should be verified as having been done so properly. FIELD_STRUCT_DESC: *ABANDONED* 1 of 3: 36-inch corrugated metal drainage pipe through the levee, 15 feet below the crown. Slide gate in a 48-inch corrugated metal pipe (CMP) riser on the waterside (WS) shoulder. Flap gate at the WS toe has been sealed shut with sealant. [Additional Reference(s): DWR Levee Log, 1993, referenced as 24 feet below the crown. USACE Sacramento O&M Manual 104, February 1960, (RM 15.20), referenced as invert elevation 24 feet below the crown]. FS Date: 2/11/2014

36-inch CMP drainpipe with flapgate on WS toe.

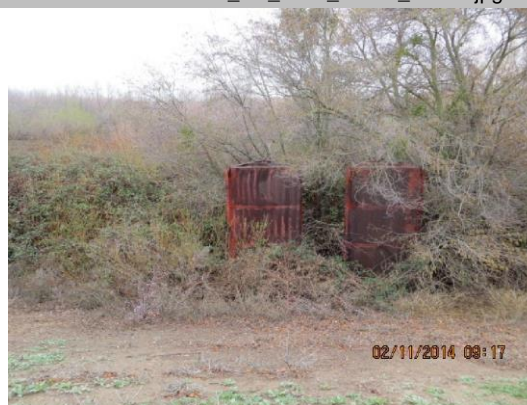
Photo 3 of 3 : UCIP\_SP\_2019\_29165\_53864.jpg

Steel weir on LS toe.

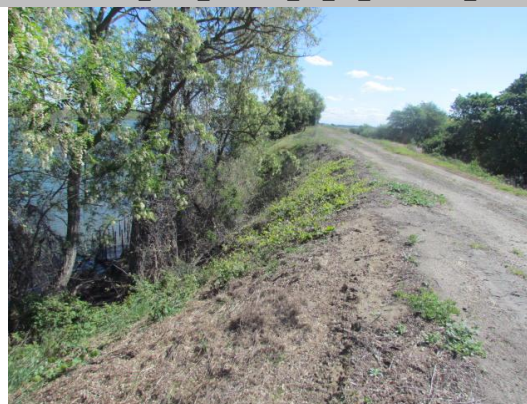
Photo 1 of 3 : SP\_2019\_RD0003\_24\_98\_20190311\_00086.jpg

Looking north at erosion on waterward slope.

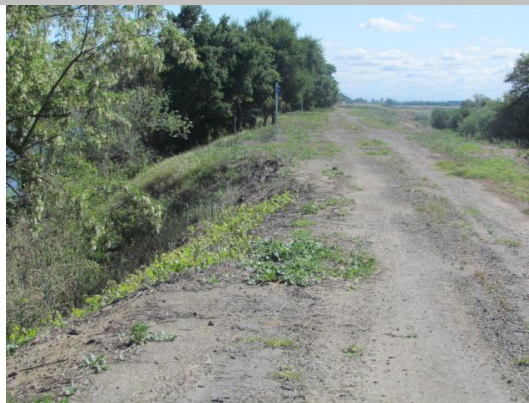
Photo 2 of 3 : SP\_2019\_RD0003\_24\_98\_20190311\_00087.jpg

Looking northwest at erosion on waterward shoulder and slope.

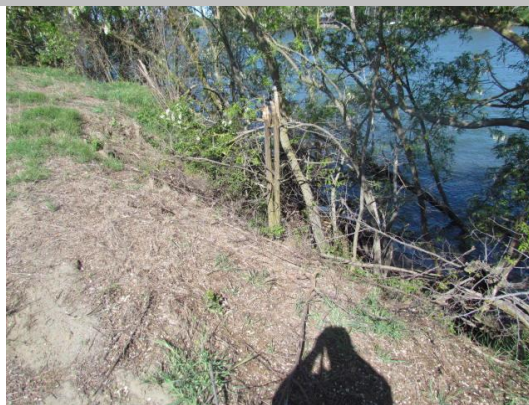
Photo 3 of 3 : SP\_2019\_RD0003\_24\_98\_20190311\_00088.jpg

Looking west at erosion on waterward slope.

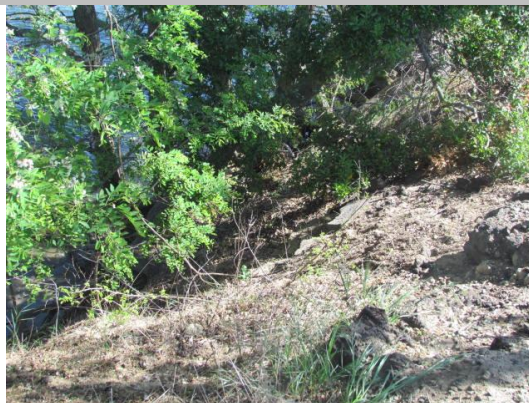
Photo 1 of 2 : SP\_2019\_RD0003\_24\_99\_20190311\_00089.jpg

Looking west at erosion on waterward slope.

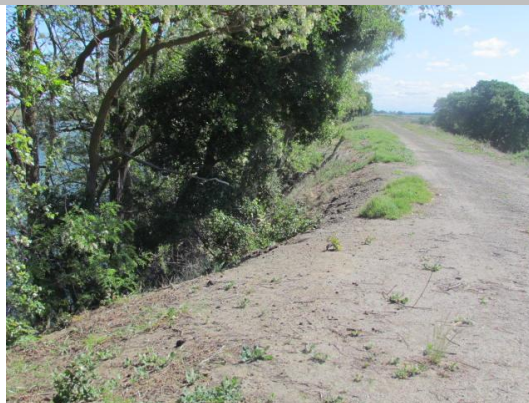
Photo 2 of 2 : SP\_2019\_RD0003\_24\_99\_20190311\_00090.jpg

Looking north at erosion on waterward shoulder and slope.

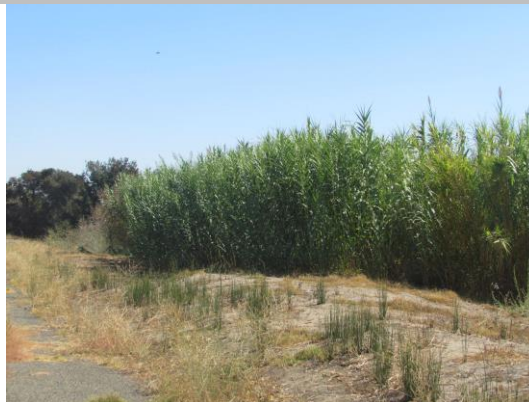
Photo 1 of 1 : SP\_2019\_RD0003\_25\_5\_20190311\_00005.jpg

Looking southeast at arundo on waterward slope. (Fall 2016)

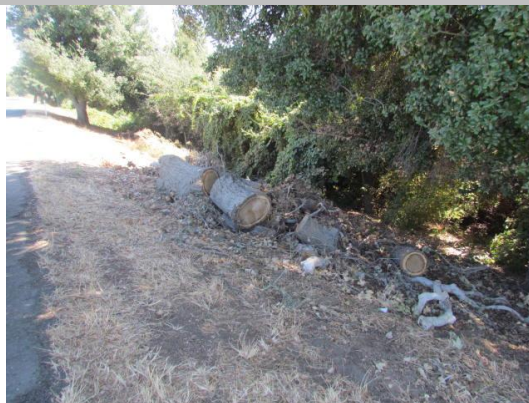
Photo 2 of 2 : SP\_2019\_RD0003\_25\_140\_20190311\_00111.jpg

Looking at tree branches and tree limbs on waterward shoulder and slope.

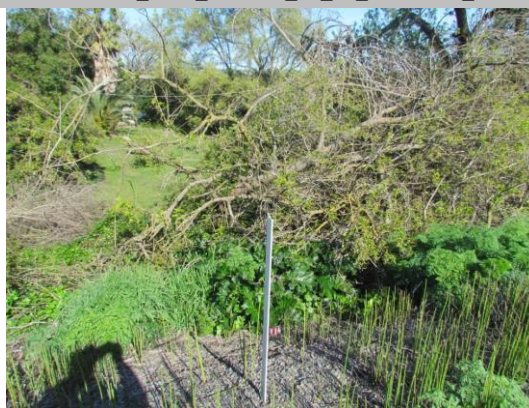
Photo 1 of 1 : SP\_2019\_RD0003\_25\_97\_20190311\_00074.jpg

Looking west at fallen tree on landward slope.

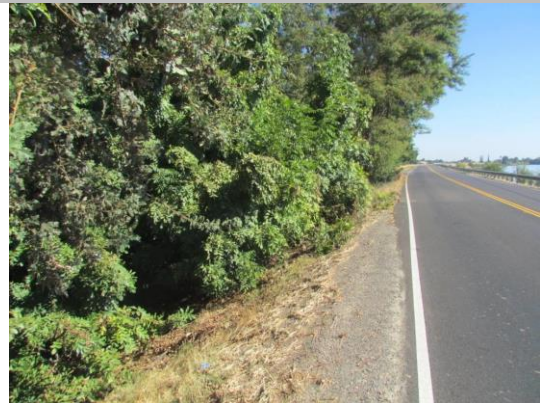
Photo 1 of 2 : SP\_2019\_RD0003\_25\_14\_20190311\_00016.jpg

LM Start	4.94	Rating **	M	Issue No.	14
LM End	4.98	Issue Type +	Ma	Location *	LS
Category	Earthen Levee			GPS Latitude/Longitude	
				Start	End
Item	Trim / Thin Trees			38.188344 °	38.188748 °
				-121.581414 °	-121.580743 °
DWR ID	DWR_RD0003_02_s_2012_14				
Comment Code					
T1 : Trim trees to at least five feet above ground level.					
Inspector Comment					
There are untrimmed trees on the landside slope and toe.

Looking northeast at dense vegetation on landside shoulder and slope.  
(Fall 2016)

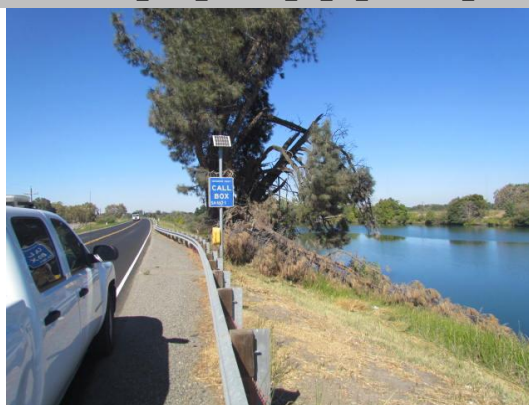
Photo 1 of 2 : SP\_2019\_RD0003\_25\_15\_20190311\_00018.jpg

Looking northeast at broken and cracked tree branches on waterward slope.

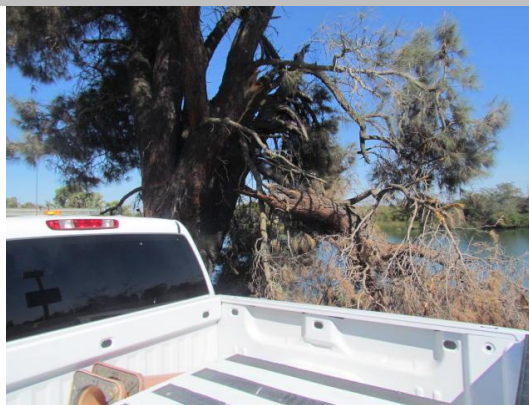
Photo 2 of 2 : SP\_2019\_RD0003\_25\_15\_20190311\_00019.jpg

Looking east at broken and cracked tree branches on waterward slope.

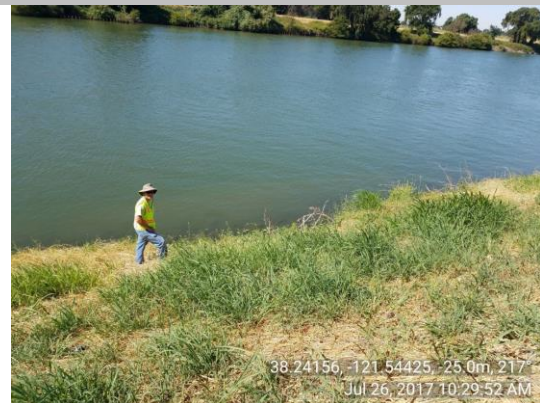
Photo 1 of 3 : SP\_2019\_RD0003\_25\_138\_20190311\_00104.jpg

LM Start	10.01	Rating **	A/W	Issue No.	138
LM End	10.03	Issue Type +	Ma	Location *	
Category	Supplemental			GPS Latitude/Longitude	
				Start	End
Item	2017 Storm Damage			38.241481 °	38.241439 °
				-121.544569 °	-121.544353 °
DWR ID	DWR_RD0003_02_f_2017_138				
Comment Code					
Inspector Comment					
Levee Evaluation Comments					
Description:District station 528+97 to 529+58, Sec. 33, T. 5 N. R. 4 E., M.D.M. Approximately 61 linear feet of erosion and sloughing exists along the water side slope of the Sacramento River (Unit 2). The erosion commences approximately 1/2 of the way down the slope from the crown and extends into the rip rap.					
Site ID No:280					
Site Designation:LMA-106					
Repair Type: Erosion					
Rating:Area of Concern					
Field Date:7/26/2017					
Notes:

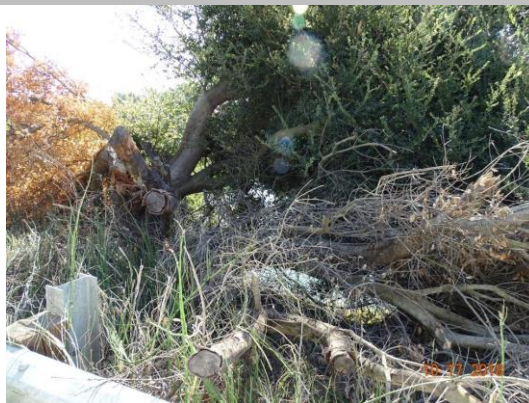
Photo 1 of 1 : SP\_2019\_RD0003\_25\_201\_20190311\_00158.jpg

View of fallen tree that has been chopped up on the waterside slope (October 2018).

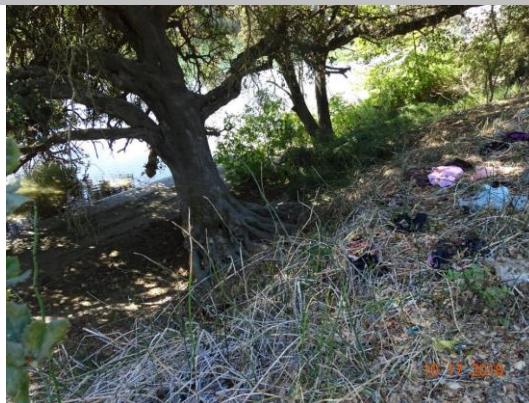
Photo 1 of 3 : SP\_2019\_RD0003\_25\_118\_20190311\_00080.jpg

View of erosion at the waterside toe (October 2018).

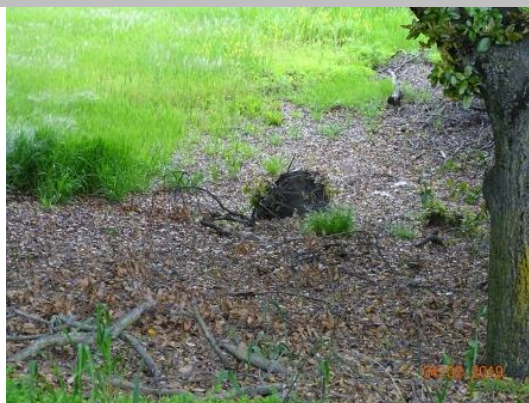
Photo 1 of 1 : SP\_2019\_RD0003\_25\_135\_20190404\_00331.jpg

View looking downslope at tree trunk at the bottom of the landside slope (Spring 2019).

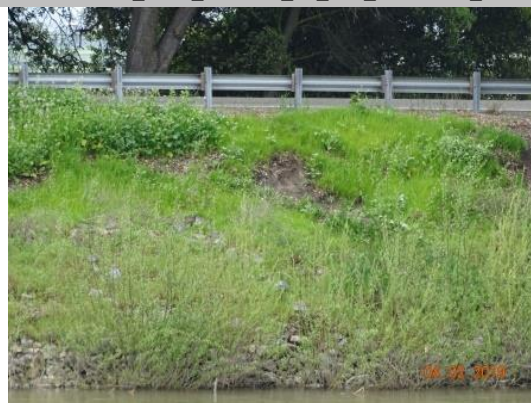
LM Start	13.43	Rating **	A/W	Issue No.	204
LM End	13.43	Issue Type +	Ma	Location *	WS
Category	Earthen Levee			GPS Latitude/Longitude	
				Start	End
Item	Erosion / Bank Caving			38.262822 °	-121.525300 °
				38.262822 °	-121.525300 °
DWR ID	DWR_RD0003_02_s_2019_204				
Comment Code					
E1 : Note and monitor erosion site.					
Inspector Comment					
Inspect potential erosion spot further when vegetation is less dense in the fall.

View looking across the Sacramento River at potential erosion spot towards the top of the waterside slope (Spring 2019).

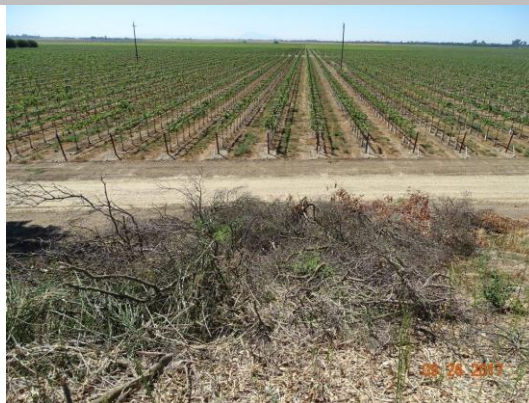
Looking southwest at the landside slope.

LM Start	15.37	Rating **	M	Issue No.	134
LM End	15.37	Issue Type +	Ma	Location *	LS
Category	Earthen Levee			GPS Latitude/Longitude	
				Start	End
Item	Encroachments			38.282243 °	38.282243 °
				-121.550917 °	-121.550917 °
DWR ID	DWR_RD0003_02_s_2017_134				
Comment Code					
PR : Prunings					
Inspector Comment					
Remove prunings from the landside slope.

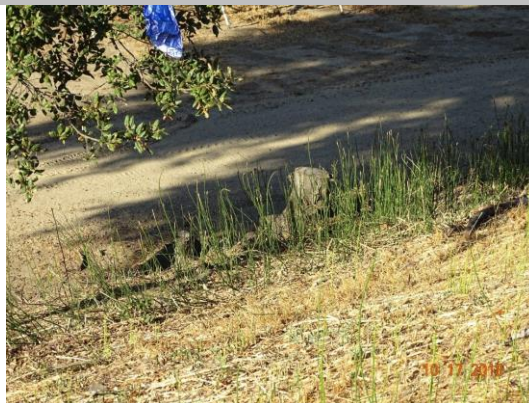
View of large stump at the landside toe of the levee (October 2018).

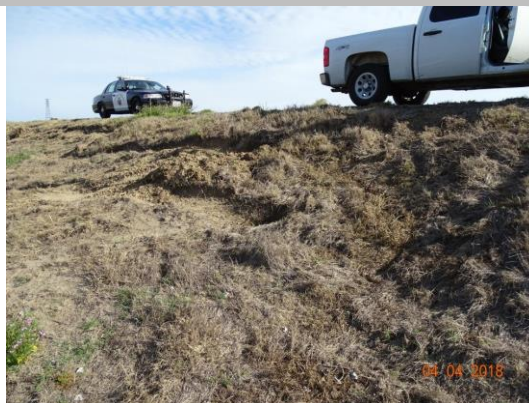
Vehicle erosion on landside slope should be repaired.

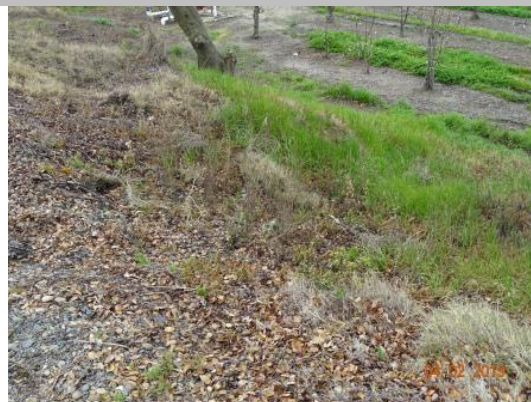
LM Start	17.27	Rating **	M	Issue No.	114
LM End	17.27	Issue Type +	Ma	Location *	LS
Category	Earthen Levee			GPS Latitude/Longitude	
				Start	End
Item	Slope Stability			38.303351 °	38.303351 °
				-121.573084 °	-121.573084 °
DWR ID	DWR_RD0003_02_s_2019_114				
Comment Code					
S1 : Repair slope instability.					
Inspector Comment					
There is a depression on the landside slope.

View looking downstream at depression on the landside slope (Spring 2019).

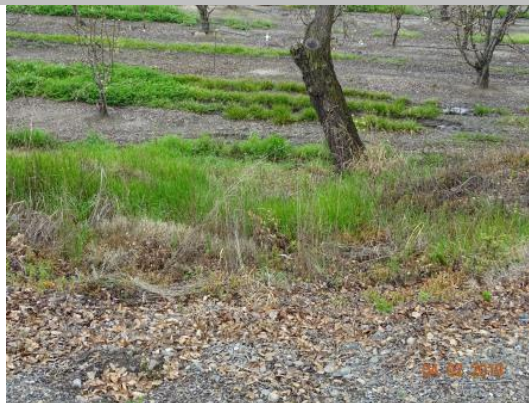
View looking downslope at depression on the landside slope (Spring 2019).

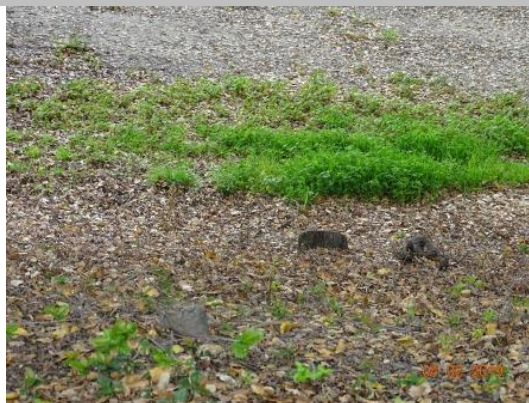
View looking downslope at tree stumps on the landside (Spring 2019).
